# X353-5B PROPULSION SYSTEM FLIGHTWORTHINESS TEST REPORT

LIFT FAN FLIGHT RESEARCH AIRCRAFT PROGRAM

CONTRACT DA 44-177-TC-715

GENERAL ELECTRIC COMPANY

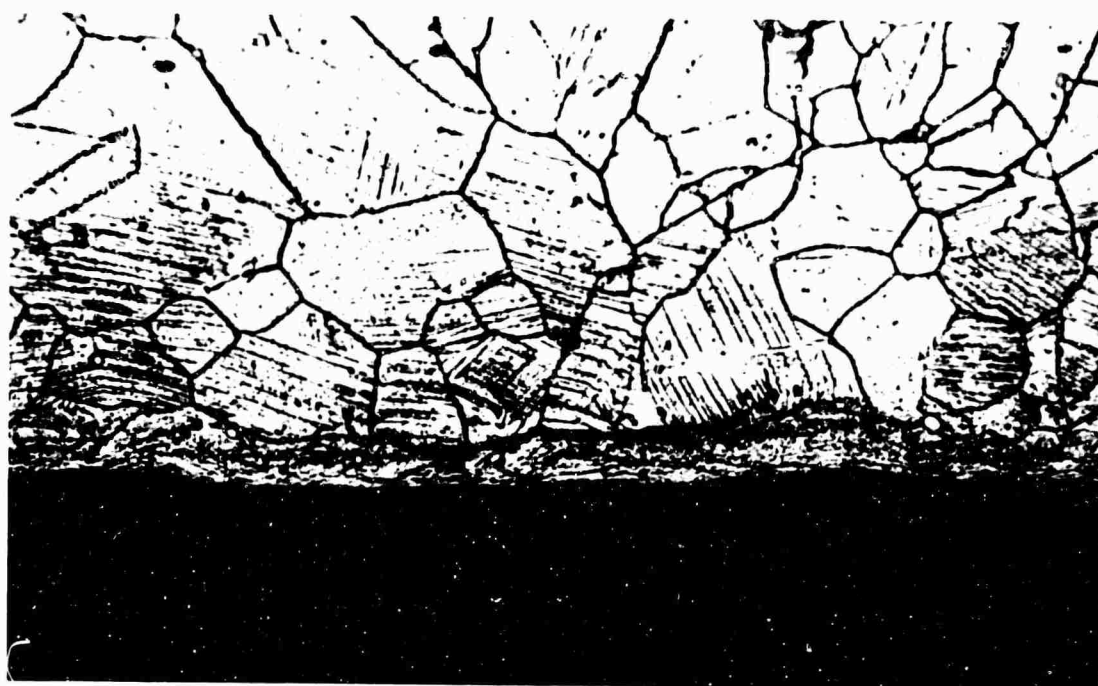
Figure I-72 A. Etched 500X Microscopic Examination of Grain Structure of Figure I-71A  
B. Etched 500A Microscopic Examination of Grain Structure of Figure I-71D

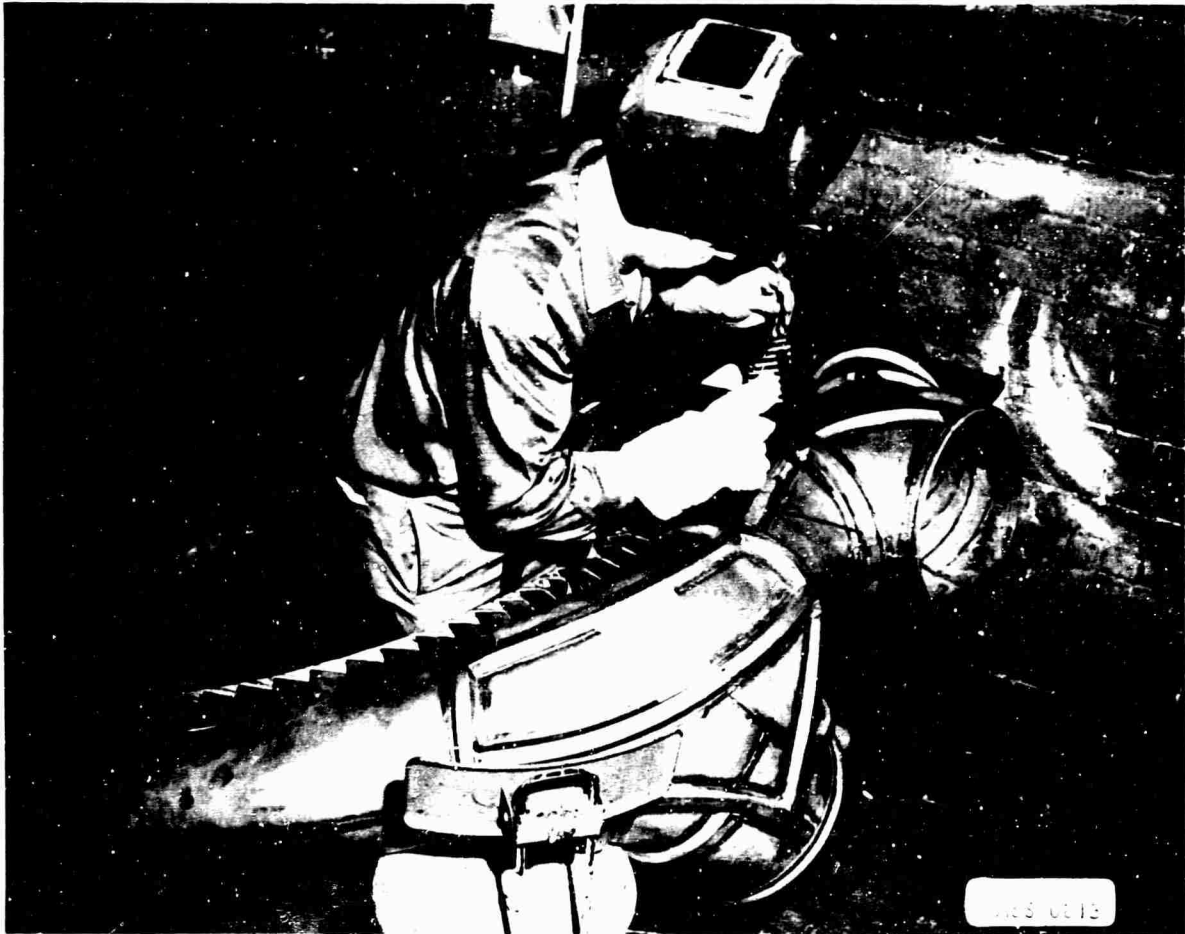
Figure I-80. Hat Section Added To The Lift Fan Scroll
